# PHASE I INSPECTION REPORT

## 6 NATIONAL DAM SAFETY PROGRAM

Long Bottom Branch Dam, Inventory Number VA-02702. Buchanan County, Virginia.  
Phase I Inspection Report.

NAME OF DAM: LONG BOTTOM BRANCH DAM  
LOCATION: BUCHANAN COUNTY, VIRGINIA  
INVENTORY NUMBER: VA. NO. 02702

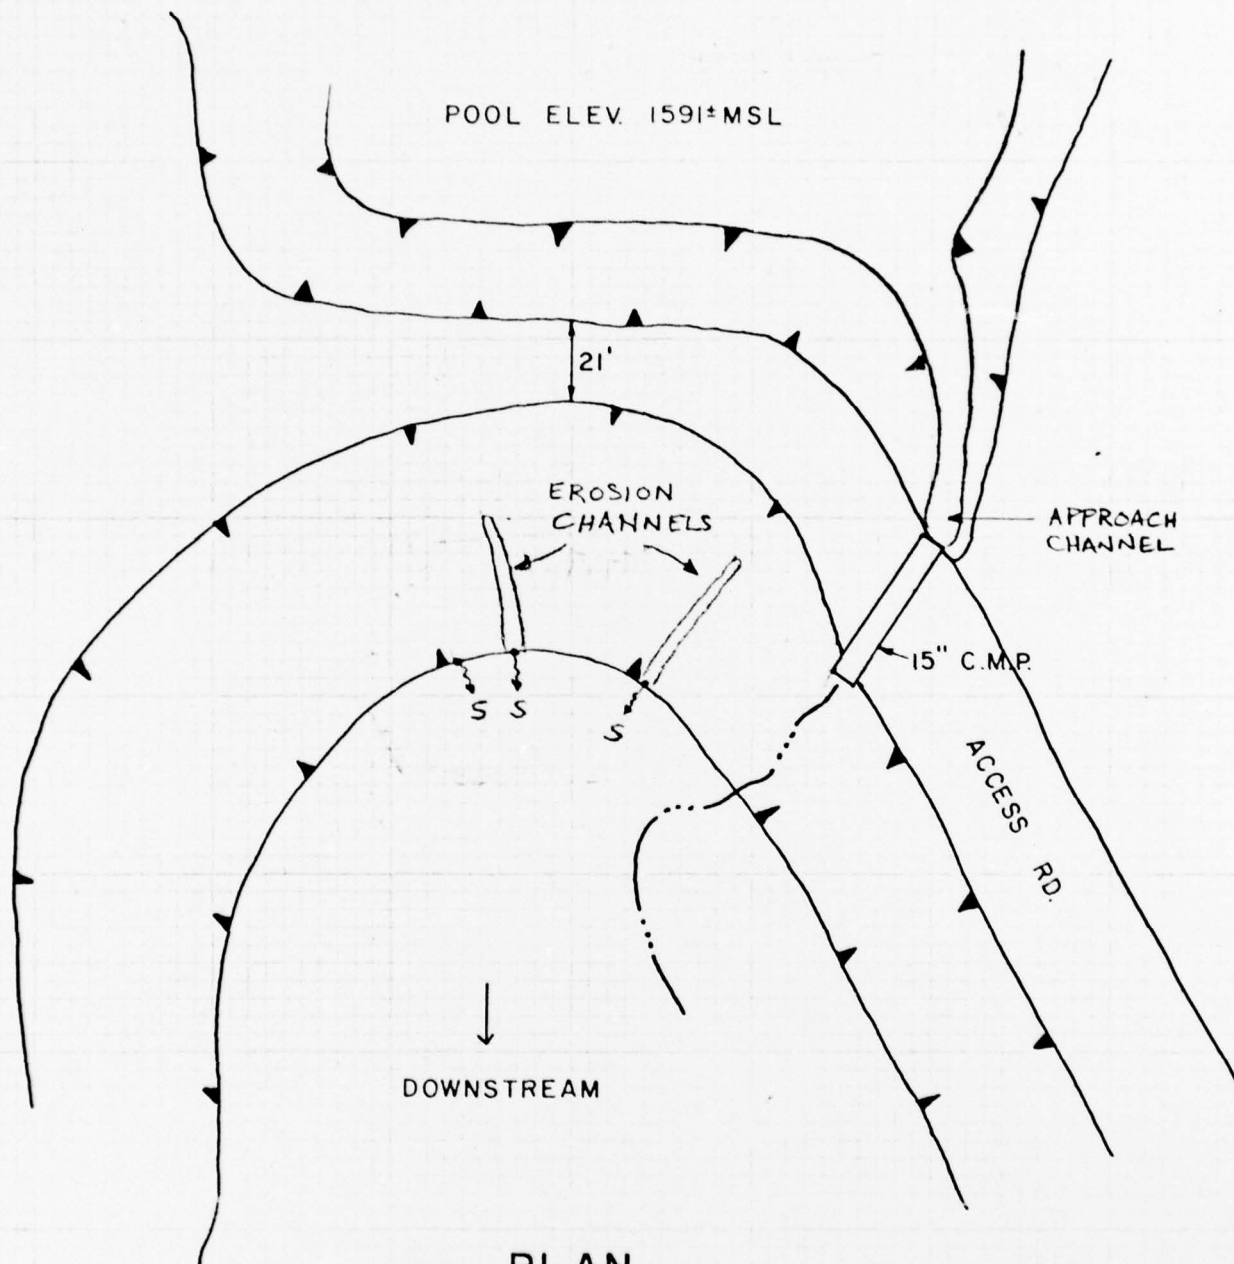
PLATE NO. 2

encountered on the downstream slope along the left abutment and to the right of the dam center where the dam curves into the right abutment. These eroded areas were up to 3 ft wide, 1 to 2 ft deep, and extended from about halfway down the slope to the toe. Three seeps, each flowing at 2 gpm<sup>±</sup> were encountered. Two occur along the toe of the eroded channels or washes and the third was approximately 10 ft right of the right erosion channel along the toe of the slope. Heavy iron staining was associated with the three seeps. Erosion and seepage features are illustrated on Plate 2, Appendix I.

1.3 Sloughing or Erosion: Two erosion channels or washes were observed on the downstream slope along the left abutment and along the right edge of slope where the dam curves. The eroded areas were up to 3 ft wide and 1 to 2 ft deep. They extend from about half way down the slope to the toe. Erosion also exists at the spillway outlet.

1.7 Seepage: Three seeps were encountered during the inspection. Two were located along the toe of the two eroded channels or washes and the third was approximately 20 ft right of the right erosion channel along the toe of slope. Seepage from all three areas was estimated as 2 gpm<sup>±</sup>. Heavy iron staining was generally present along seepage paths.

Eroded areas and excavations created by removal of trees should be backfilled with compacted fill. The embankment should be reseeded and all surface drainage should be diverted to prevent further erosion.

7.3.1 Seepage observed along the downstream toe of the embankment should be monitored quarterly to detect any increase in flow rates which may cause piping within the embankment.

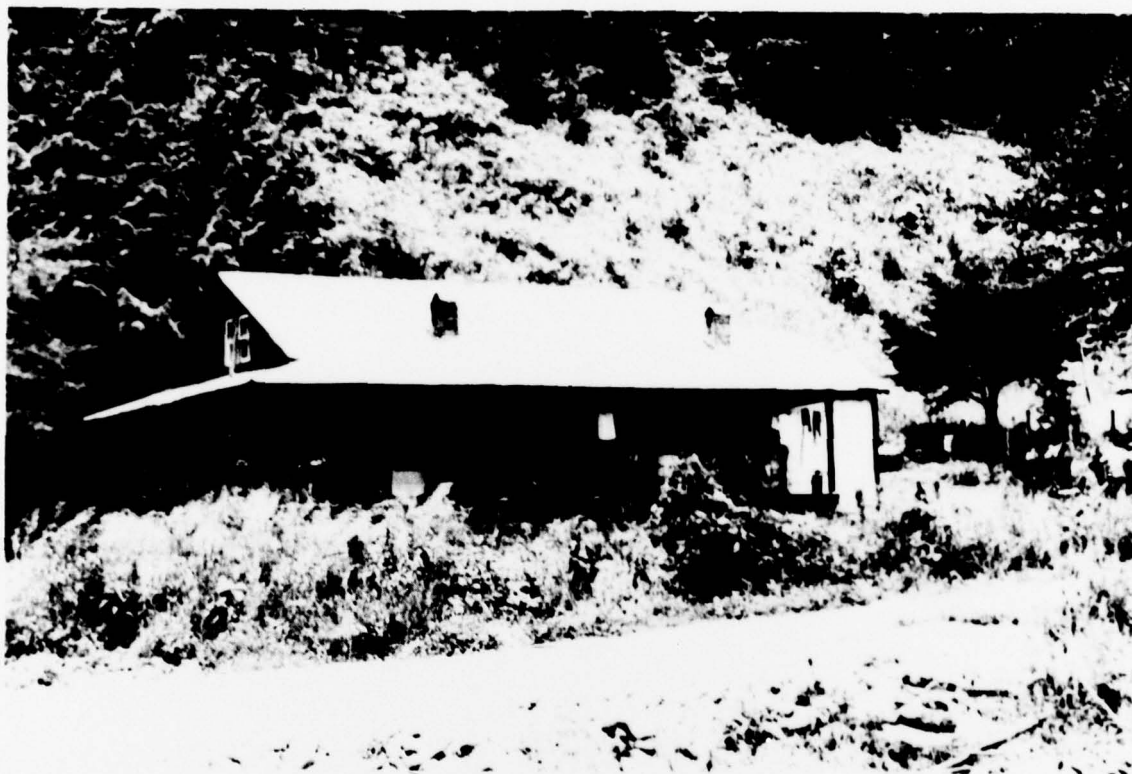
HOUSE LOCATED DOWNSTREAM IN FLOODPLAIN. THE SLOPE IN  
BACKGROUND IS TYPICAL OF SIDE SLOPES BETWEEN IMPOUNDMENT  
AND THIS HOME.

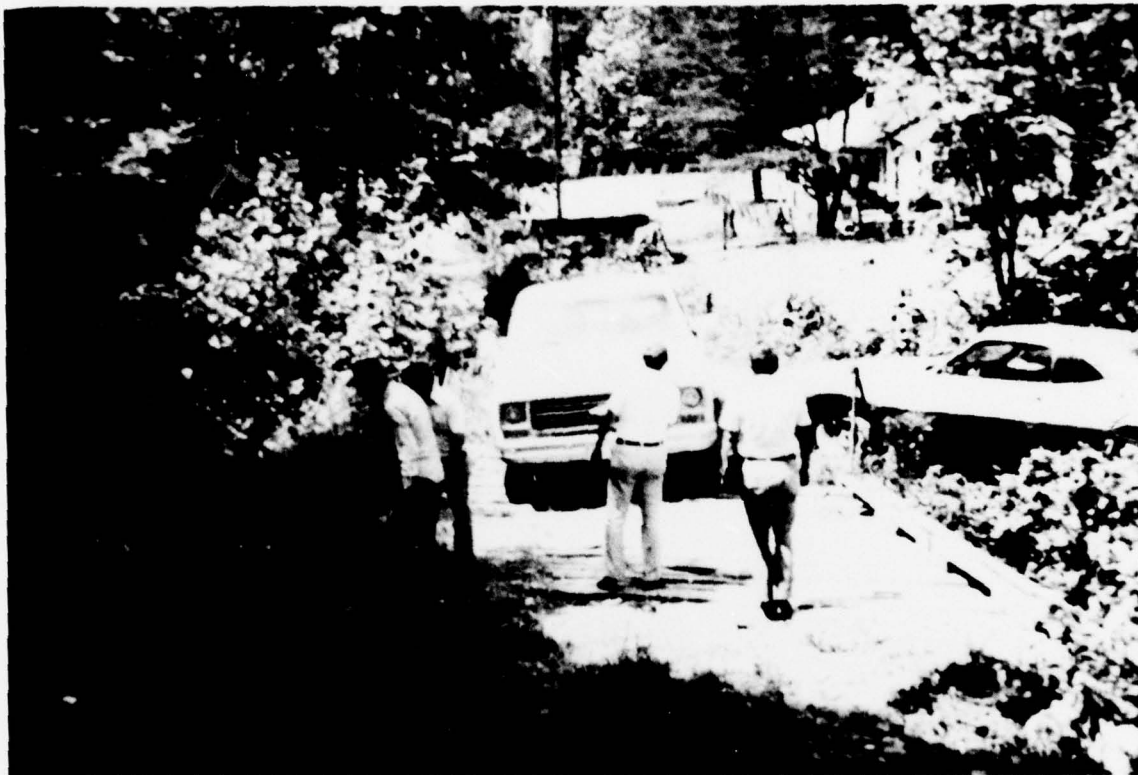
VIEW SHOWING WOODEN ACCESS BRIDGE APPROXIMATELY 2½ MILES  
DOWNSTREAM AND THE FIRST HOUSE IN FLOODPLAIN DOWNSTREAM

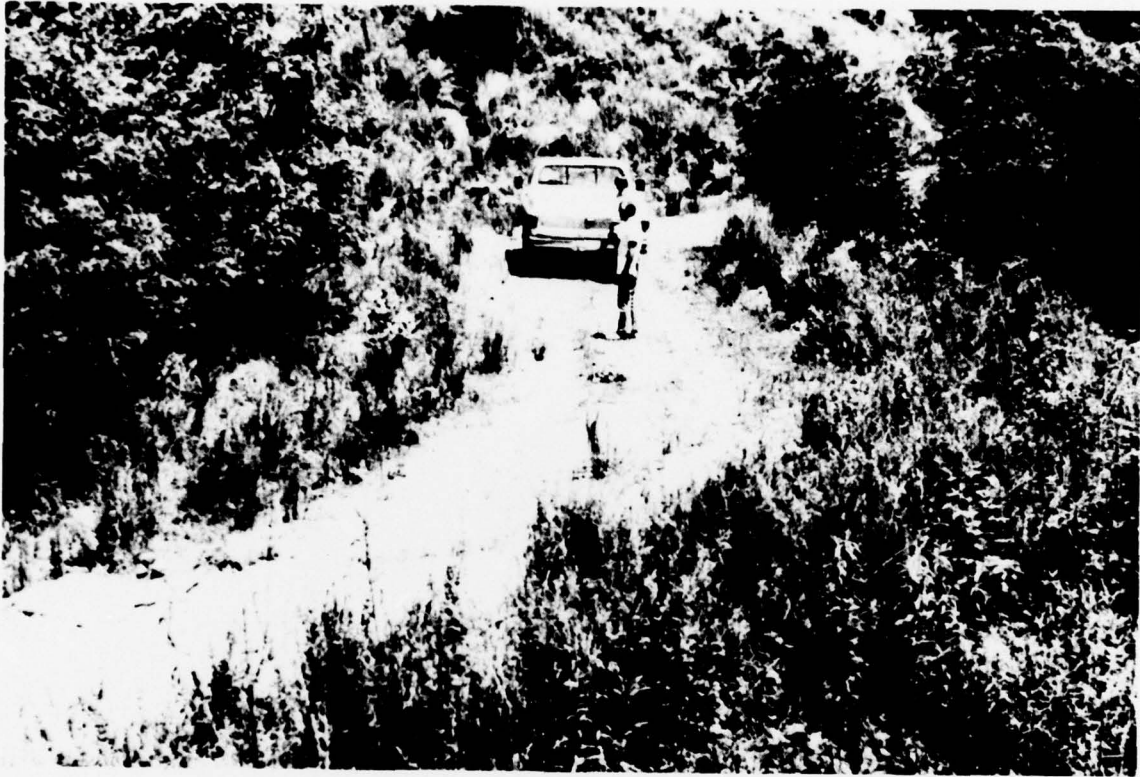
VIEW SHOWING HAUL ROAD ACROSS CREST OF DAM

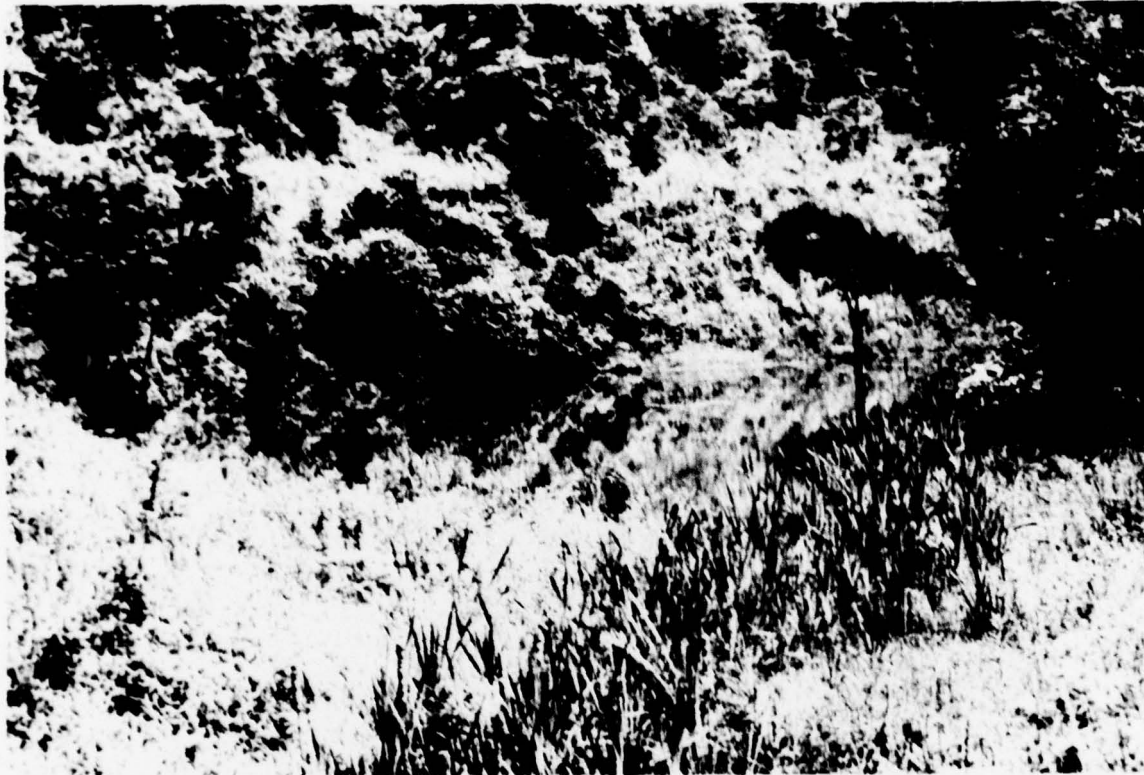
VIEW LOOKING UPSTREAM FROM IMPOUNDMENT. NOTE: GRASS  
SPILLWAY IN FOREGROUND AND TYPICAL SIDE SLOPES IN BACKGROUND.

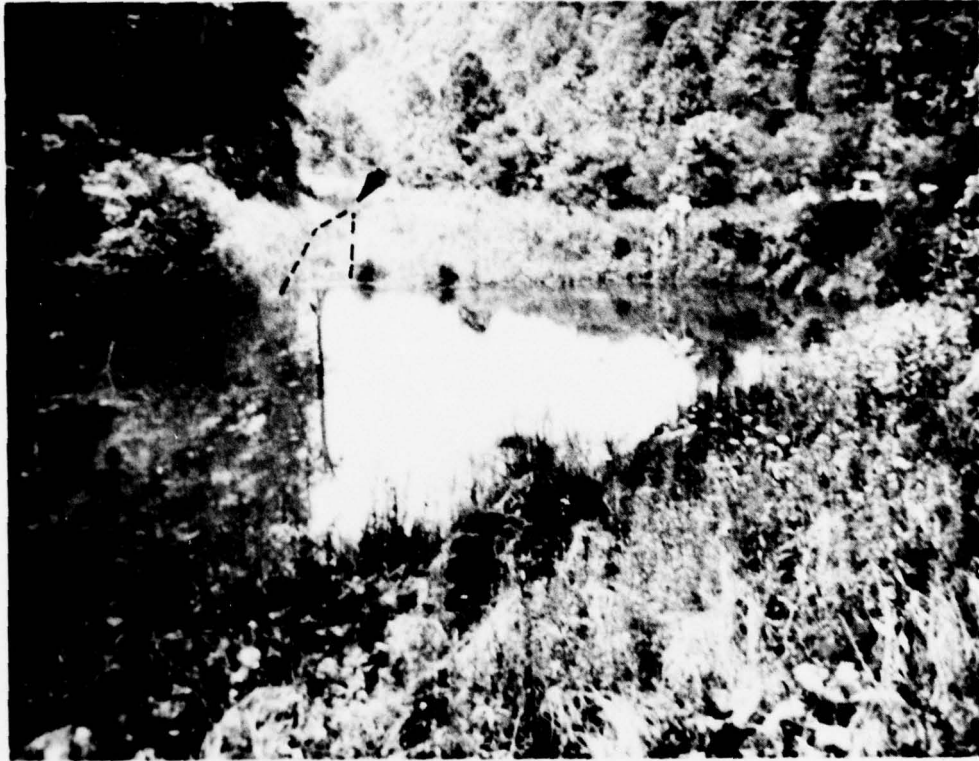
VIEW OF UPSTREAM FACE OF EMBANKMENT. NOTE: DASH LINES  
INDICATE LOCATION OF GRASS SPILLWAY AND ARROW INDICATES  
CM PIPE SPILLWAY.
